INSPECTION REPORT

For the Property at:
123 MAIN ST
GLENSIDE, PA

Prepared for: JOHN J SAMPLE
Inspection Date: Wednesday, March 31, 2010
Prepared by: Dana Hillerby

RE: Report No. 1018
123 Main St
Glenside, PA
19038

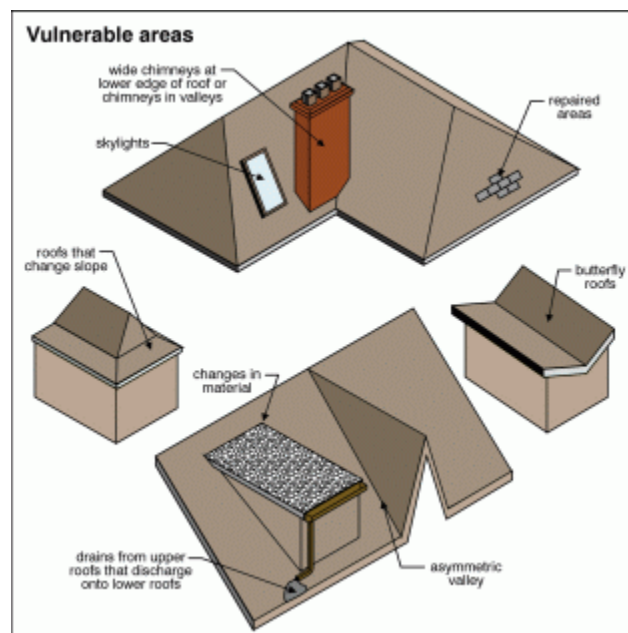
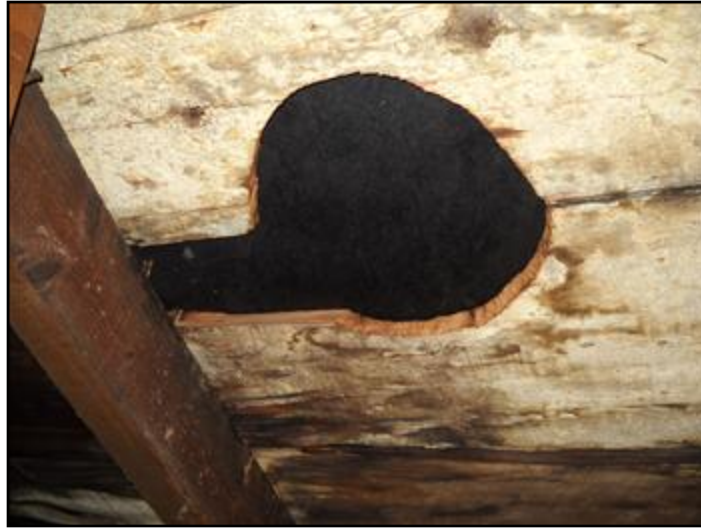
1. Hole in roof planking

There is a 12" hole in the roof sheathing from a previous vent. The vent was removed and a new roof laid over the hole without filling and supporting the hole. This is going to cause someone walking the roof to fall through. Recommend having a carpenter repairing this area.

Implication(s): Chance of water damage to contents, finishes and/or structure

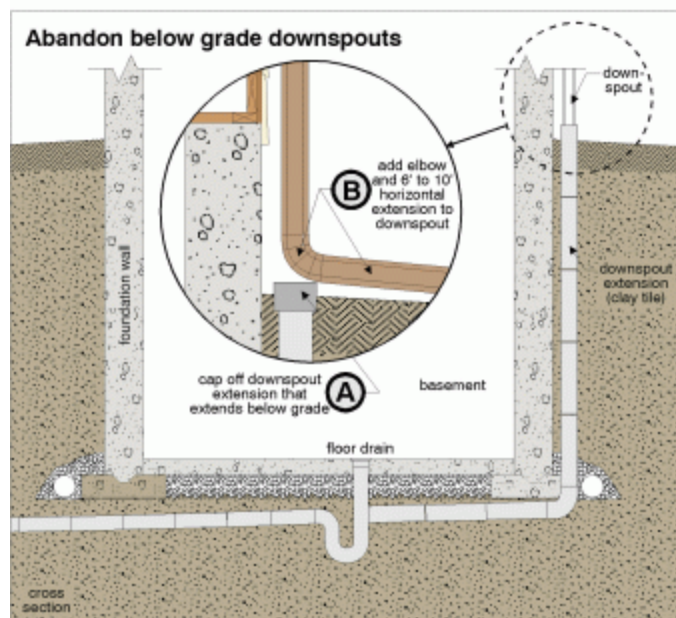
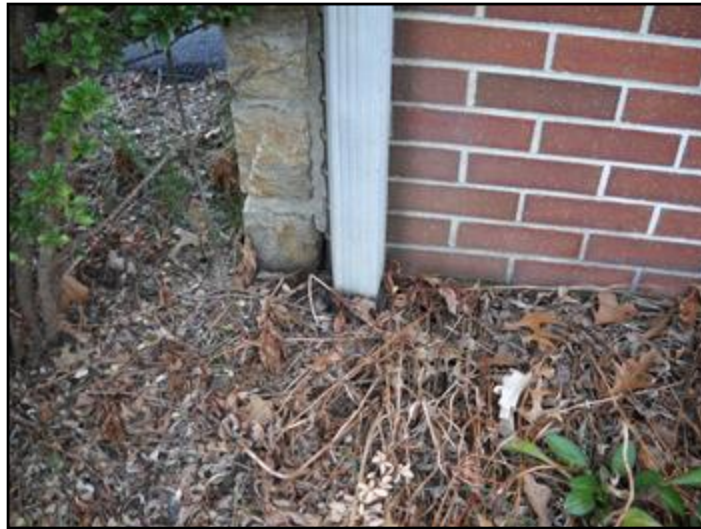
2. Downspout

Downspouts discharging below grade. Recommend flushing with garden hose to verify they are clear and that they discharge away from the house.

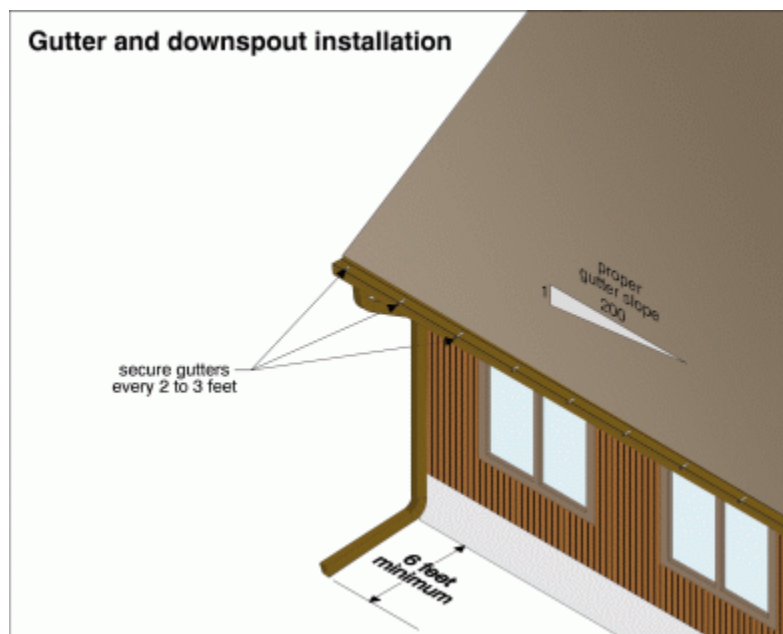
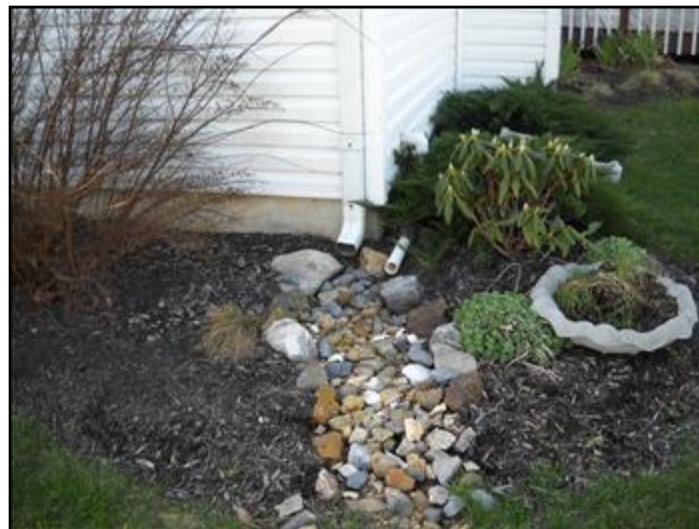
3. Downspout in rear

Condition: • [Downspouts end too close to building](#)

Recommend that all downspouts discharge at least 6 feet from the house.

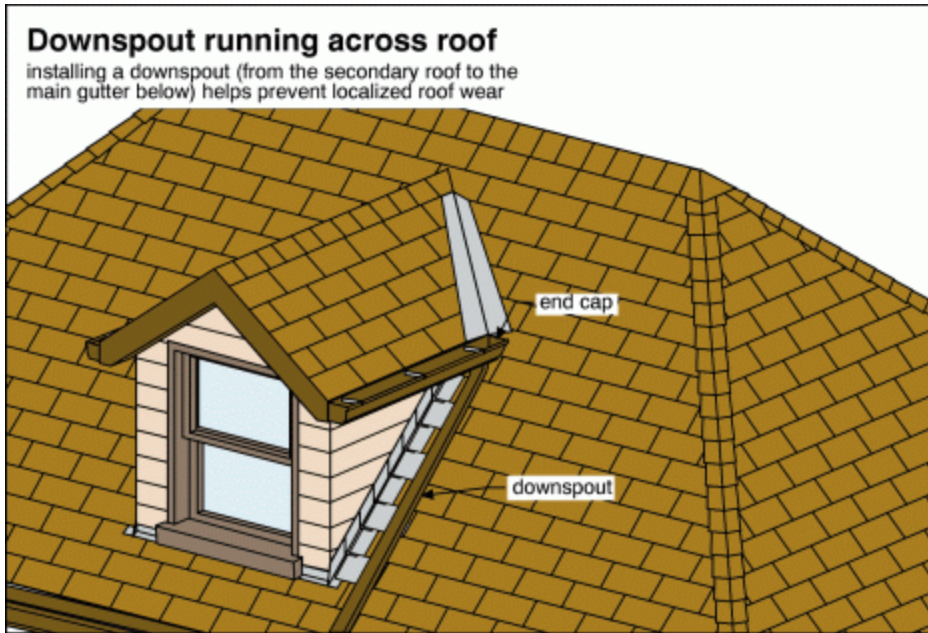
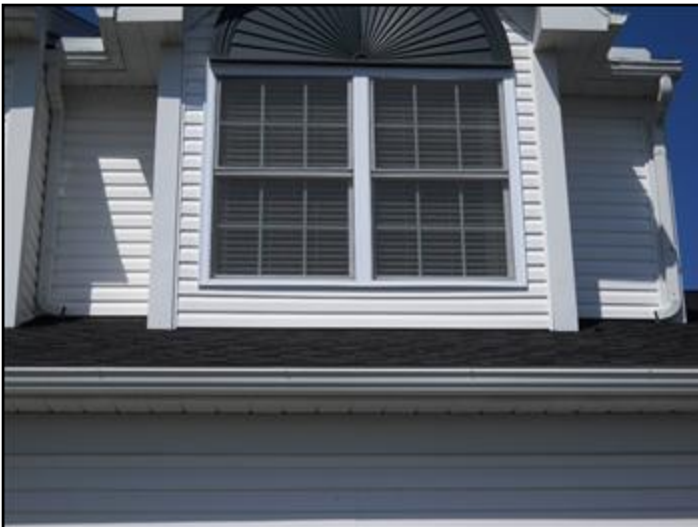
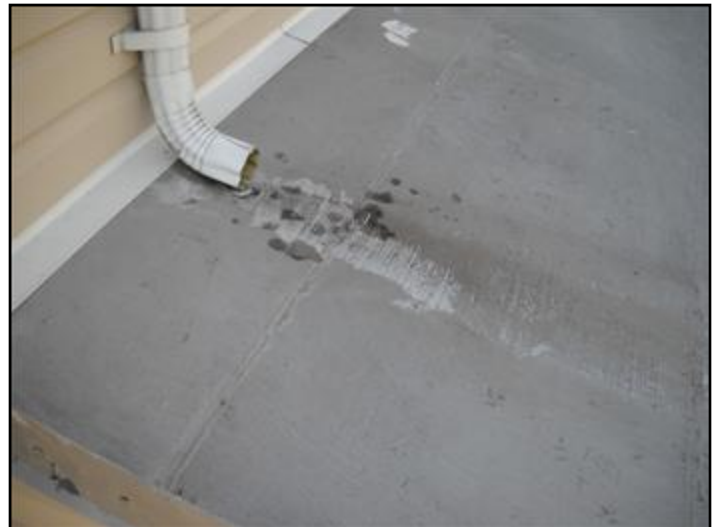
Condition: • [Downspouts discharging onto roofs](#)

Downspouts are discharging onto roofs. This can cause premature roof wear as the runoff from two roofs are effecting concentrated areas.

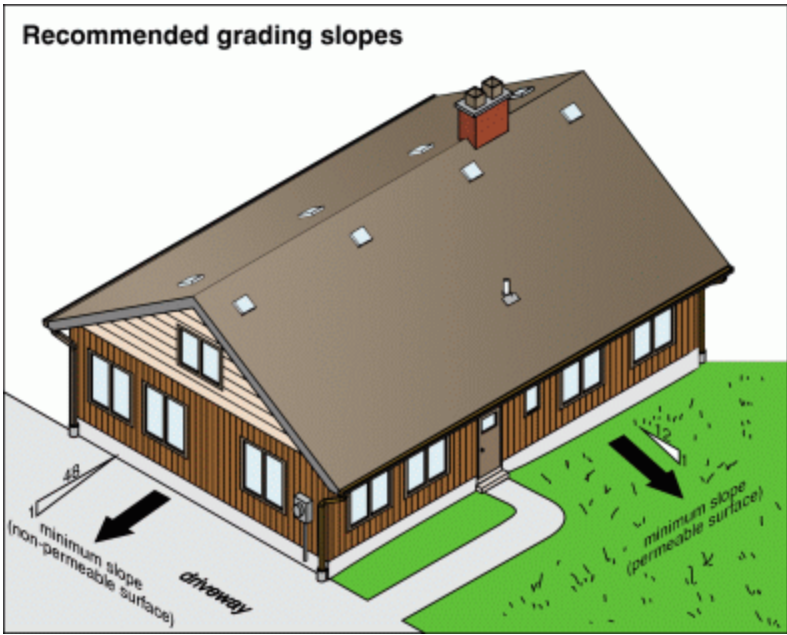
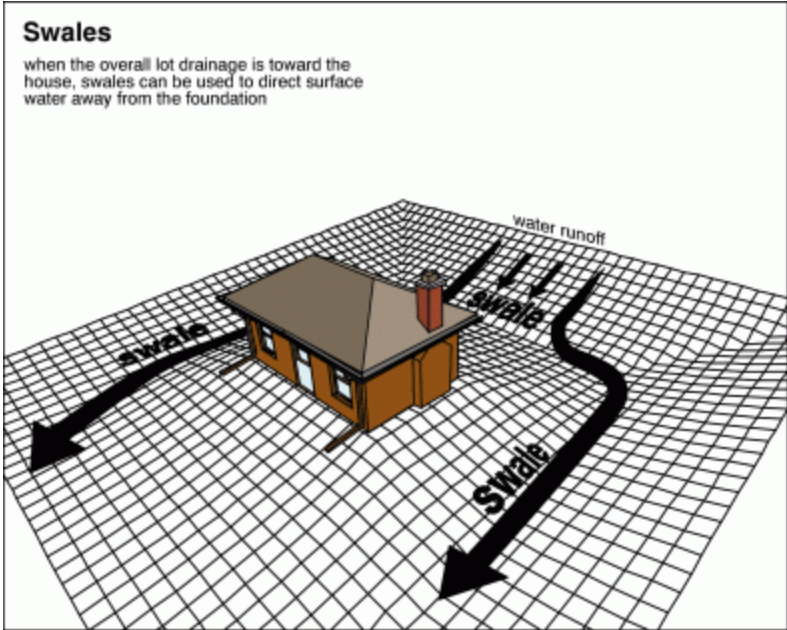
Condition: • [Improper slope](#)

Recommend adding soil to the side of the building to increase the slope away from the house. This could also assist in preventing water penetration into the foundation.

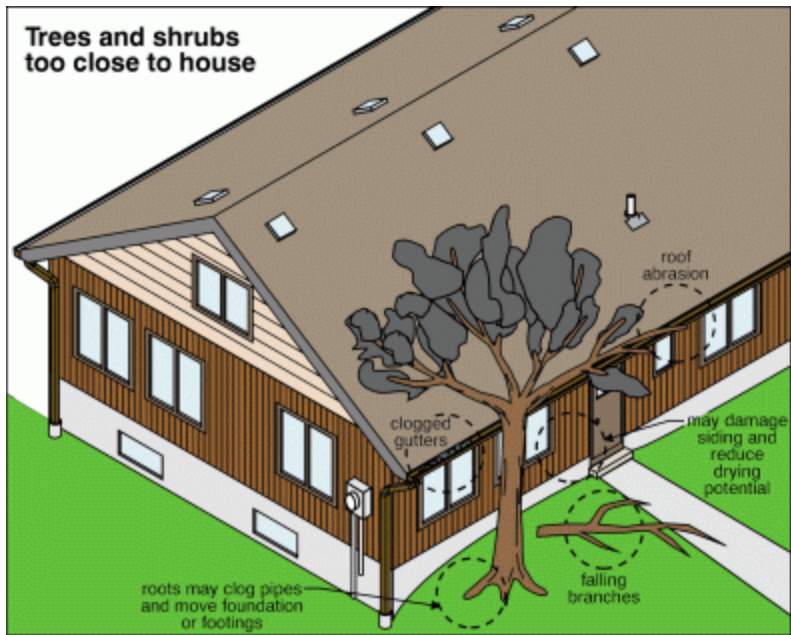
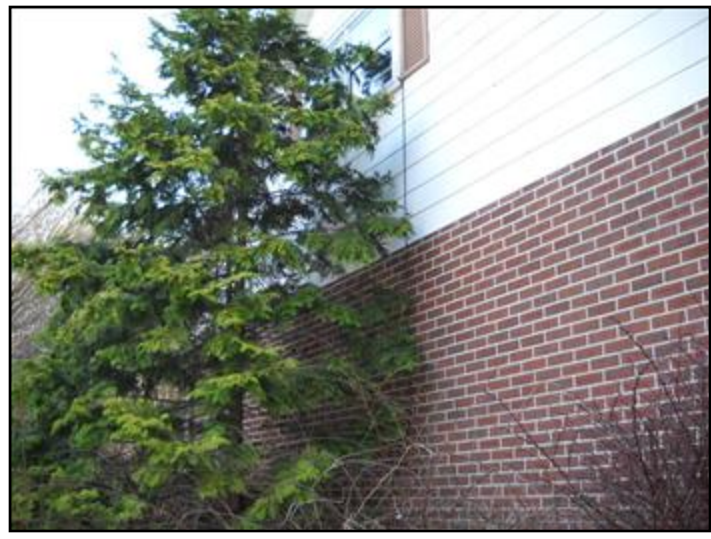
6. Tree rubbing on the house

Condition: • [Trees or shrubs too close to house](#)

Recommend trimming the tree back as this can cause damage to the vinyl siding

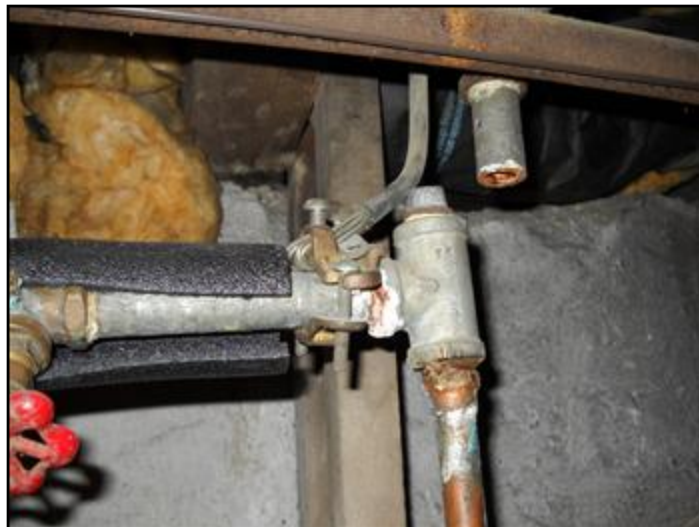
7. Loose ground

Condition: • [Poor connections](#)

The ground connection on the water pipe is loose thereby not providing the safety required by the grounding. Recommend replacing the ground wire connector with a smaller size and tighten.

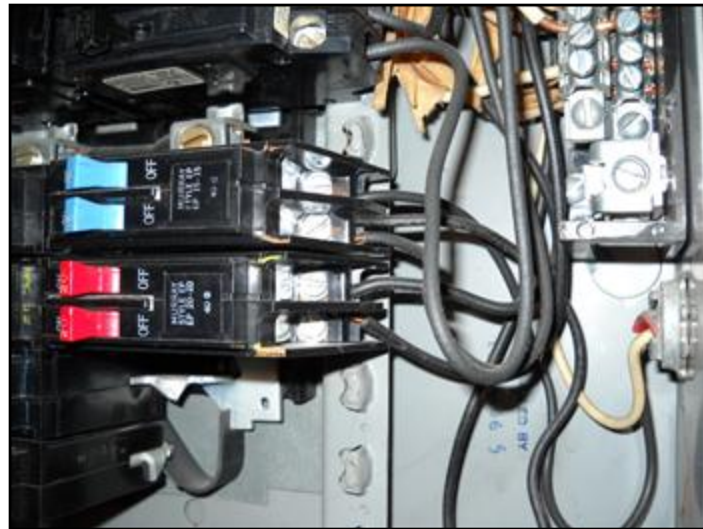
8. Double taps

Condition: • [Double taps](#)

When more than one circuit wire is attached to a breaker, this is referred to as a double tap. Recommend having an electrician adding another breaker and separating the two circuits.

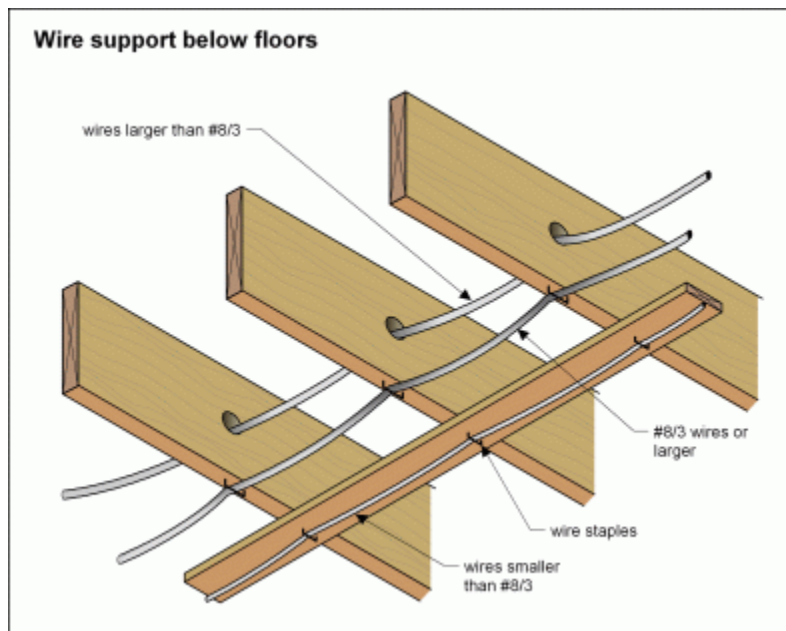
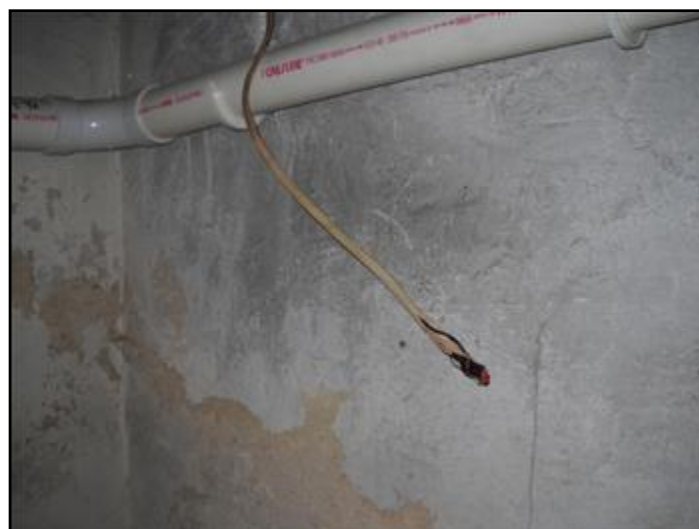
9. Live wire

Condition: • [Exposed on walls or ceilings](#)

Exposed live wire hanging from ceiling in basement. Recommend either removing wire if not used or terminating in an approved junction box secured on the ceiling.

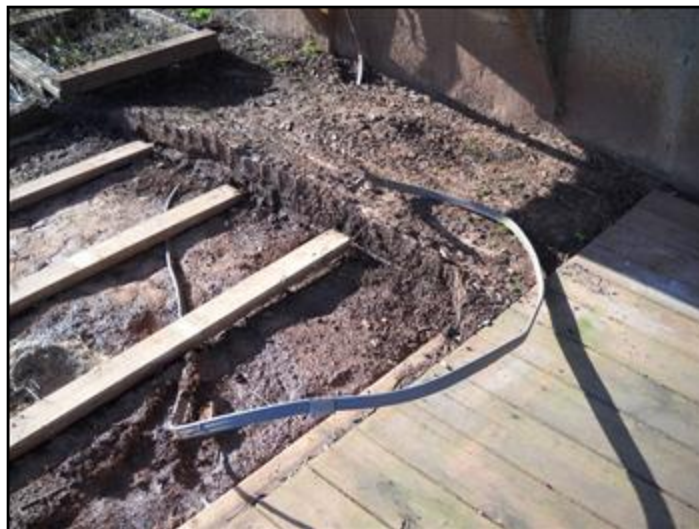
10. Exposed 50amp wire

Condition: • [Abandoned wire](#)

There is a 50amp wire at the rear of the house from a disconnected hot tub. Recommend removing the wire and terminating the circuit end in an approved junction box.

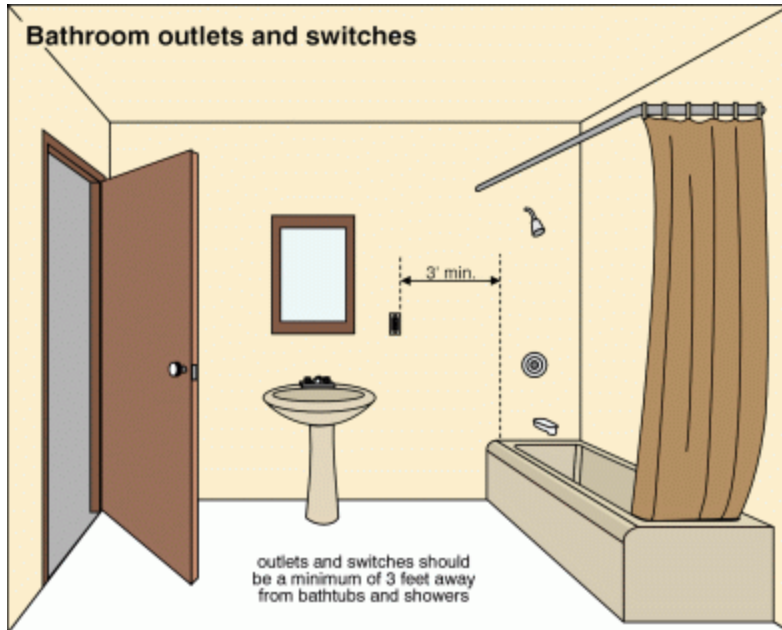
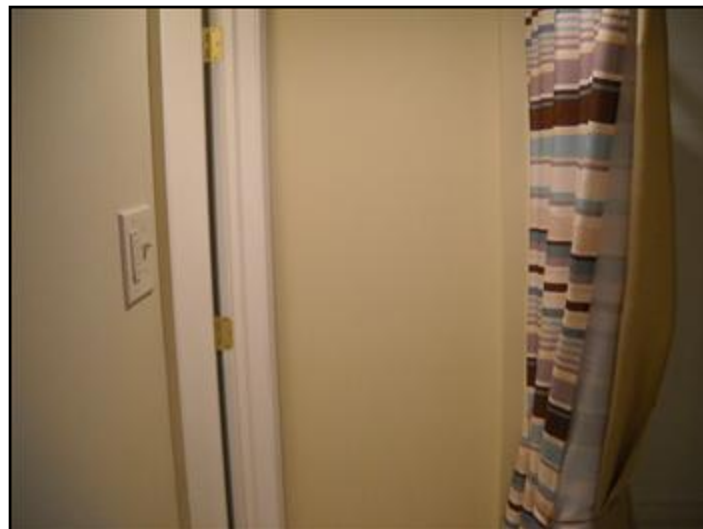
11. Bath light switch

Condition: • [Poor location in bathroom](#)

The bath light switch is only two feet from the shower. This can allow someone standing in the shower and flipping the light switch. This is a shock hazard. Recommend moving the switch at least three feet from the shower.

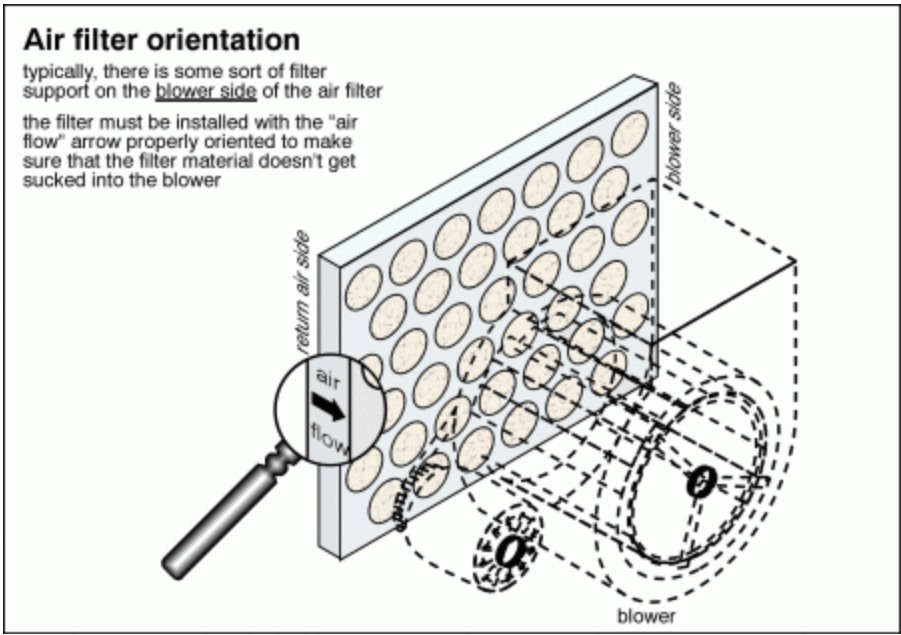
GAS FURNACE \ Mechanical air filter
Condition: • [Installed backwards](#)
Furnace filter dirty and installed backwards. Recommend changing the filter every 30 days to keep the circulated air and furnace clean.
Implication(s): Increased heating costs | Reduced comfort
Location: Basement
Task: Correct
Time: Immediate
Cost: Less than \$100

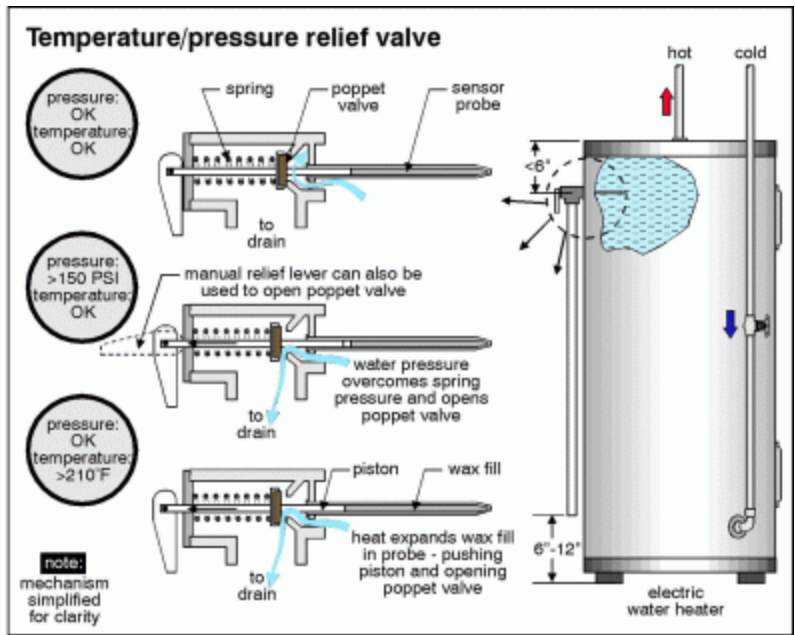
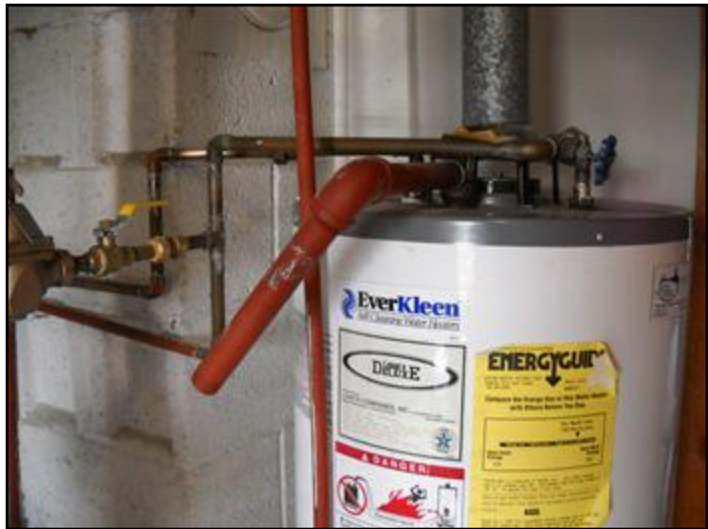
12. Safety discharge tube

Condition: • [Discharge tube too short](#)

Water heater discharge tube is threaded on the end and too short. This pipe is suppose to extend to about 6" from the floor and not threaded on the bottom. This pipe is in case of emergency discharge and could cause scalding in its current condition.
